Dental Implant Placement in Focal Osteoporotic Bone Marrow Defect: a Case Report and Treatment Recommendations

J Oral Maxillofac Res 2022;13(3):e5

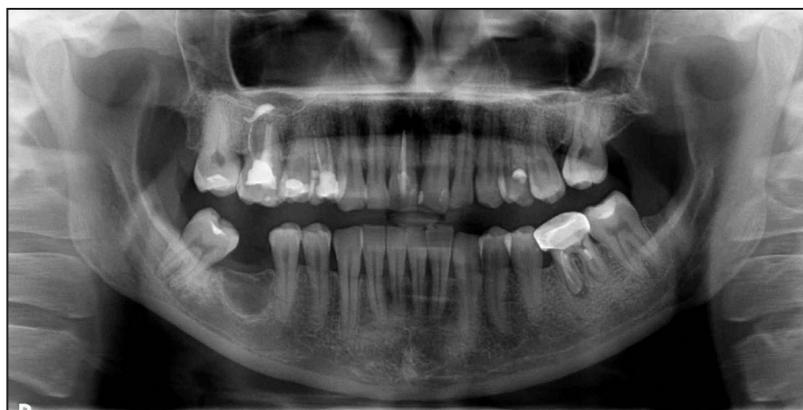
Figure 1. Panoramic radiography demonstrating 2 x 2 cm radiolucency with irregular borders located in tooth #46 region. The margins of the radiolucency correspond to extraction socket borders of the tooth #46.

Under local anaesthesia Straumann® solid screw implant (Straumann AG; Basel, Switzerland) placement operation was planned according to manufacturer's recommendation. When drilling with a pilot drill (2.2 mm diameter), after penetrating the cortical layer of the jaw, the drill fell down into the bone without resistance. The osteotomy in the cortical layer was widened using second (2.8 mm diameter) and third (3.5 mm diameter) drills. A 3.5 mm diameter depth gauge was used to check the preparation depth. The gauge was inserted into the implant bed without pressure until it rested against the bone. The patient was asked if she felt irritation or pain in the inferior alveolar nerve. The answer was negative. Furthermore, gentle curettage of the bone walls was performed using a curette through the implant bed. There were no signs of any pathology like cyst, bony haematomas and etcetera. A diagnosis of focal osteoporotic bone marrow defect was established.

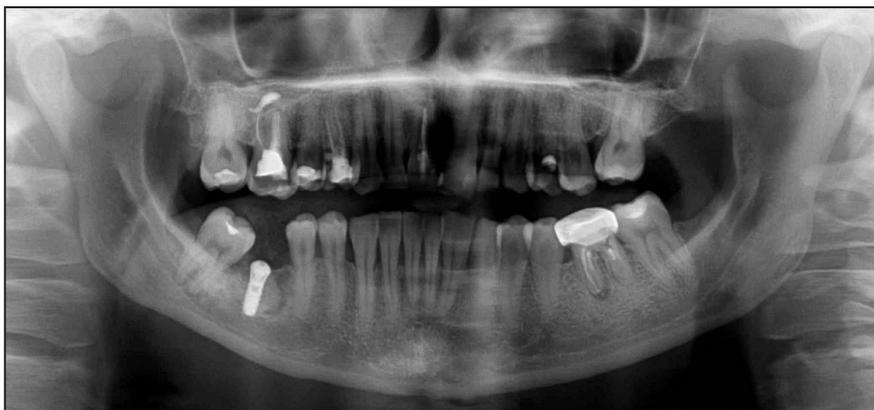
Figure 2. Panoramic radiography demonstrating the osteoporotic focus filled with natural bovine bone substitute and a 10 mm long, 4.1 mm diameter Straumann® Tissue Level implant placed with the shoulder of the implant resting on the margins of the osteotomy.

the osteotomy. Before inserting the implant, the osteoporotic focus was filled with natural bovine bone substitute Cerabone® (Botiss biomaterials GmbH; Zossen, Germany). The diameter of the Cerabone® granules was 0.5 - 1 mm. The granules were gently condensed to the sides - to the buccal and lingual walls until they filled the entire cavity. A 3.5 mm diameter depth gauge then was gently inserted to create a bed for the implant and to avoid pressure on the mandibular canal when screwing in the implant. Finally, the dental implant was inserted with a hand ratchet until the shoulder of the implant rested on the cortical layer of the mandible. The engagement of the implant neck into the bone ensured the minimal primary stability of the implant that was clinically felt. Medications and postoperative recommendations were prescribed after dental implant surgery. The healing was uneventful. The implant was left to heal submerged for 4 months. After 4 months, stage II surgery was done, and soft tissue correction was performed. Cement-retained metal ceramic crown was attached and control panoramic radiograph was performed (Figure 2). The patient was enrolled in an oral hygiene and dental implant care program.

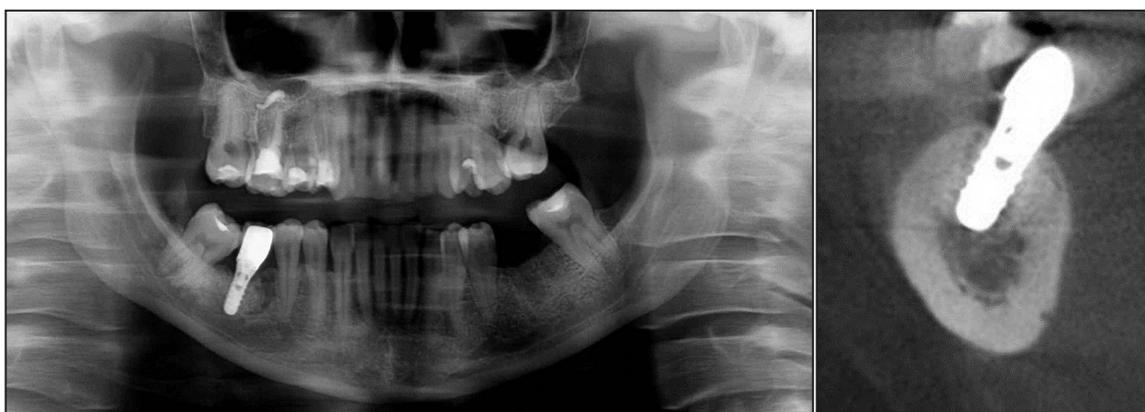
Figure 3. Patient's radiographic examination after 6-year follow-up: A = panoramic radiography; B = CBCT axial plane, demonstrating no signs of peri-implantitis, marginal bone loss, or failed osseointegration.

Annual regular follow-up showed no complications. A control panoramic radiograph and CBCT (Figure 3) taken in August 2022 showed no signs of peri-implantitis, marginal bone loss, or failed osseointegration.
